Boston Edison

Pilgrim Nuclear Power Station
Rocky Hill Road
Plymouth, Massachusetts 02360

The enclosed Licensee Event Report (LER) 97-007-00, "Safeguards Buses De-Energized and Losses of Off-Site Power During Severe Storm While Shut Down", is submitted in accordance with 10 CFR Part 50.73.

TITLE (4) Safeguards Buses De-Energized and Losses of Off-Site Power During Severe Storm While Shut Down																								
EVENT DATE (6)			LER NUMBER (6)				REPORT DATE (7)			OTHER FACILITIES INVOLVED (8)														
MONTH	DAY	YEAR	YEAR	SEQUENTIAL NUMBER	REVISION NUMBER	MONTH	DAY	YEAR	FACILITY NAME						DOCKET NUMBER									
04	01	97	97	007	00	05	01	97	N/A						05000									
									FACILITY NAME						DOCKET NUMBER									
									N/A						05000									
OPERATING MODE (9)		N		THIS REPORT IS SUBMITTED PURSUANT TO THE REQUIREMENTS OF 10 CFR: (Check one or more) (11)

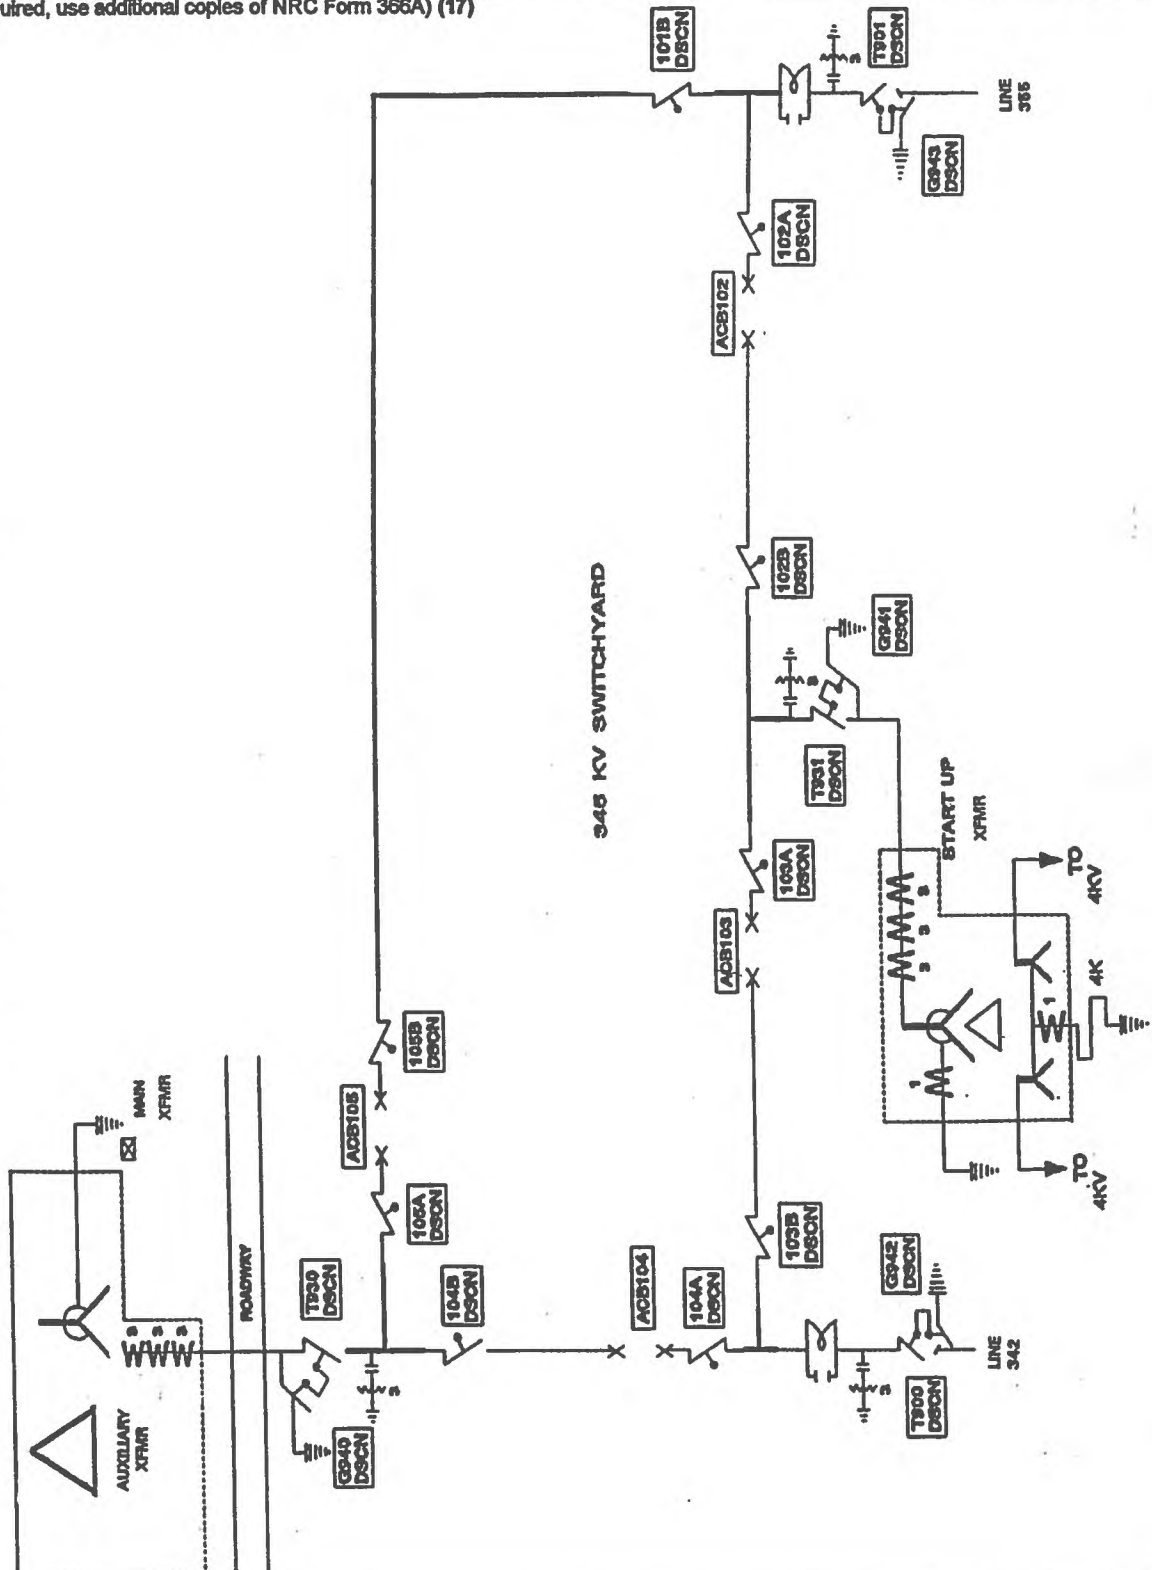
ONE LINE DIAGRAM - 345 KV SWITCHYARD

- The preferred source of off-site power, 345 Kv transmission lines 342 and 355, was energized. The 345 Kv switchyard air circuit breakers ACBs 102, 103, 104 and 105 were closed. The startup transformer (SUT) was energized from lines 342 (via ACB-103) and 355 (via ACB-102). A new main transformer had been moved onto its platform but was neither electrically nor mechanically connected, and the unit auxiliary transformer was not available because of the main transformer status. Located at the end of this report is a simplified single line drawing of the 345 Kv switchyard.

At 2221 hours, ACBs 102 and 105 automatically tripped (opened), line 355 de-energized and re-energized, and ACB-102 automatically reclosed. ACB-105 remained open as designed. The event was consistent with transmission system electrical protection design and transmission system disturbances being experienced during the storm. An employee report of arcing in the switchyard or a possible lightning strike prompted a walkdown of the switchyard. The walkdown revealed no evidence of arcing or lightning strike. After the walkdown, ACB-105 was reclosed in accordance with regional power authority (REMVEC) switching orders. The closing of ACB-105 re-established the 345 Kv ring bus.
